REPUBLIC OF THE MARSHALL ISLANDS

STELLAR DAISY CASUALTY INVESTIGATION REPORT

Loss of Buoyancy and Foundering with Multiple Loss of Life

South Atlantic Ocean | 31 March 2017

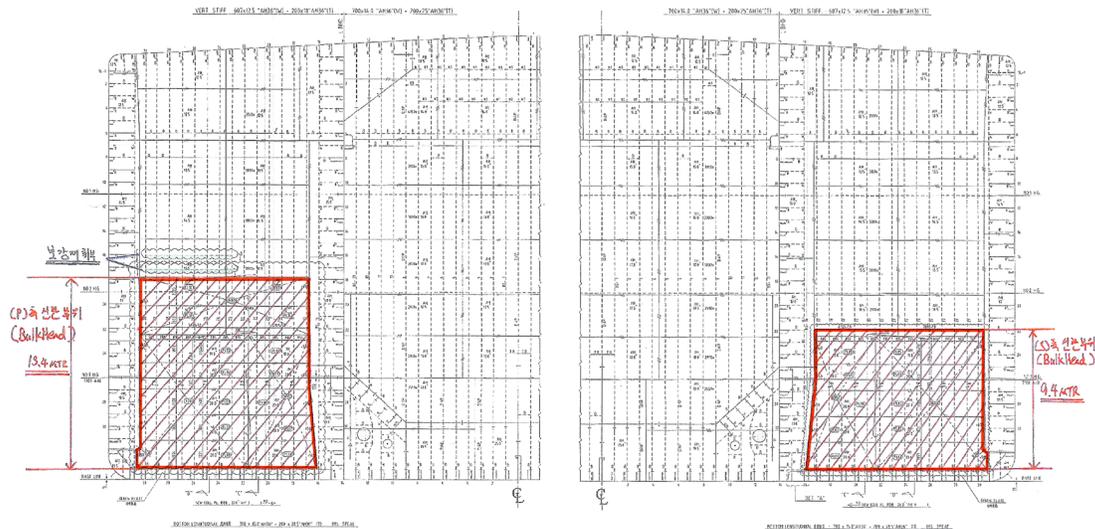
P/S WBTs because they contained ballast water, but that he was informed by the Master, C/O, and ship's Superintendent that they had examined this transverse bulkhead before STELLAR DAISY entered the shipyard and had not observed any damage.⁹³

Figure 8: Transverse bulkhead at frame No. 65 starboard (left) and port (right). The side shown is the No. 3 P/S WBTs. The hatch marks denote the damaged area.

54. Based on the findings of the damage survey conducted by the KR surveyor who attended STELLAR DAISY at the Zesco Shipyard in August 2016 and the Master's Statement of Facts, KR conducted a failure analysis to determine the cause of the observed damage of the transverse bulkhead at frame No. 65.⁹⁴ During the Administrator's marine safety investigation in the loss of STELLAR DAISY, KR informed the Administrator it determined the damage of the transverse bulkhead at frame No. 65 was caused by the force of buoyance pushing against the bottom shell as the ship worked in the seas and that the damage should be renewed to original scantlings.⁹⁵ KR also informed the Administrator it considered the damage of the transverse bulkhead at frame No. 65 to be isolated.

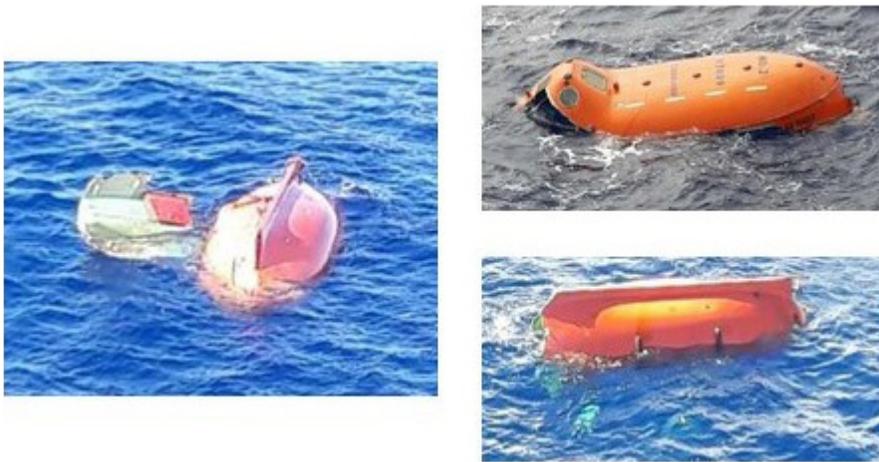
103. ELPIDA also reported sighting two life boats.¹⁴¹ Both life boats were floating capsized. The top of STELLAR DAISY’s No. 2 life boat was separated from the hull (see Figure 14). There were no indications that members of STELLAR DAISY’s crew were on board either of the life boats. Two additional life rafts were also sighted.¹⁴² One was reported to be floating upright in good condition without any of STELLAR DAISY’s crew onboard and the other was capsized.¹⁴³

Figure 14: STELLAR DAISY’s life boats. The No. 1 life boat is on the left. The top and the hull of the No. 2 life boat, which were found floating separately, are on the right.

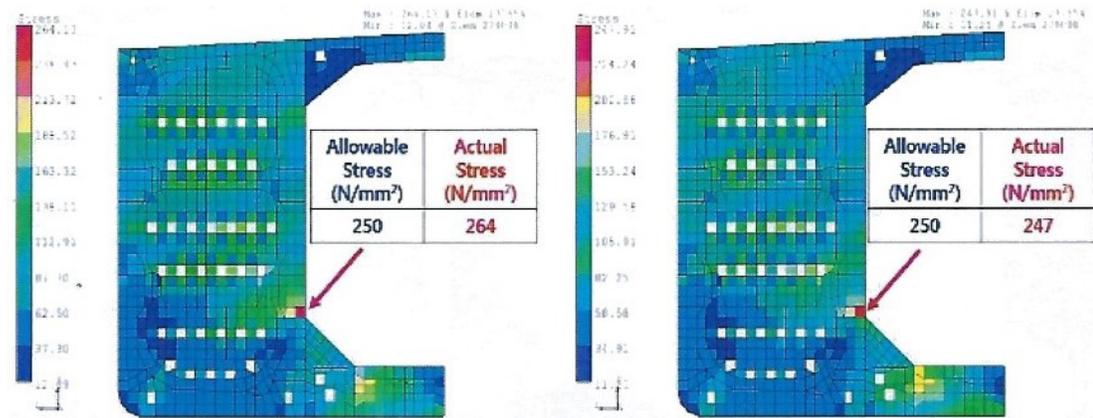
111. KR determined that the FEA results indicated that the stresses in way of Cargo Holds Nos. 3F and 3A was within the limits allowed by the KR Rules for Steel Ships. An area of stress exceeding the allowed limits was identified in the web of the swash bulkhead located at frame No. 79 in way of where the hopper plate is welded to the longitudinal bulkhead. This frame is located at the middle of Cargo Hold No. 2 (see Figure 15). Similar areas of stress were not identified in the other frames included in the model of the half-breadth of the hull in way of Cargo Hold No. 2. KR determined that the stress was localized. The FEA was also conducted, using the as built scantlings, to determine if the results were related to the diminution of the structure due to corrosion. The stress in this area was determined to be slightly below the allowed limits and in compliance with KR Rules for Steel Ships.

Figure 15: Stresses at frame No. 79 based on 2015 thickness measurements (left) and at time of conversion (right).

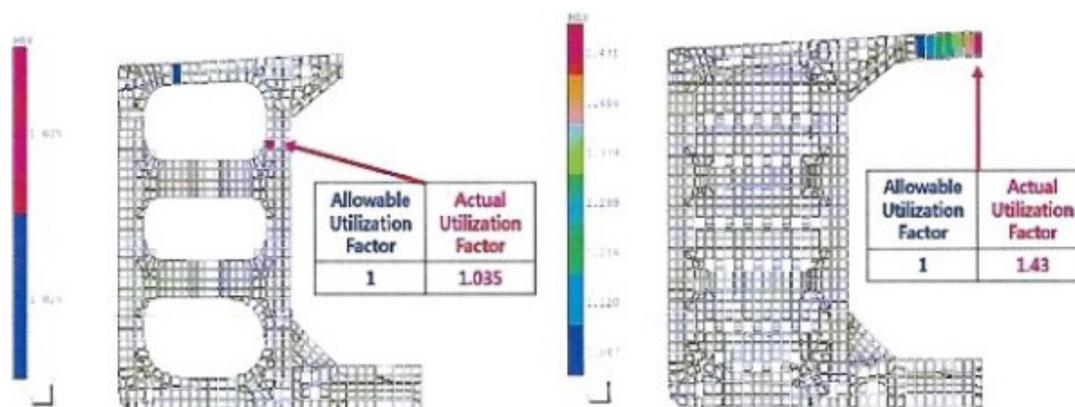
112. A buckling analysis in hogging and sagging conditions using the 2015 thickness measurements was conducted to determine if the transverse structure in way of Cargo Holds Nos. 2, 3F, and 3A met the buckling criteria in the KR Rules for Steel Ships. This analysis identified an area in the transverse web at frame No. 68 that slightly exceeded the allowed criteria. It also identified a portion of the transverse structure at frame No. 79, which was between the forward and aft hatches for Cargo Hold No. 2, that exceeded the allowed buckling criteria (see Figure 16).¹⁴⁶

¹⁴⁶ Frame No. 79 was the forward boundary for the FEA that was done at the time of the conversion and was included in the analysis that was conducted. It is noted that no buckling damage had been reported in this area while the ship was in service as a VLOC.

Figure 16: Locations where the structure did not meet the buckling criteria at frame No. 68 (left) and frame No. 79 (right).

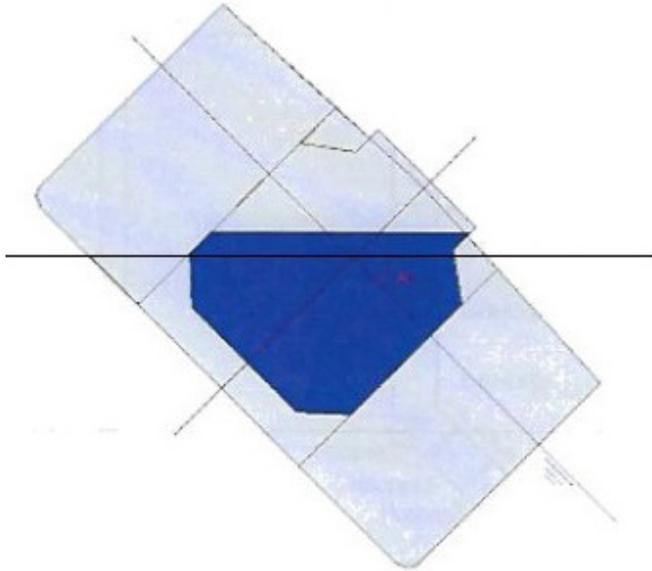
plate and longitudinals exceeded the scantlings required to support the increased pressure, the as built scantlings for the longitudinal bulkhead plate and longitudinals did not meet the required scantlings. Based on this analysis, KR determined that the longitudinal bulkheads could fail between transverse frames following a cargo shift.

Figure 17: Assumed shape of cargo pile after shifting when ship's list was 45° to port. The change of draft due to flooding is not shown.

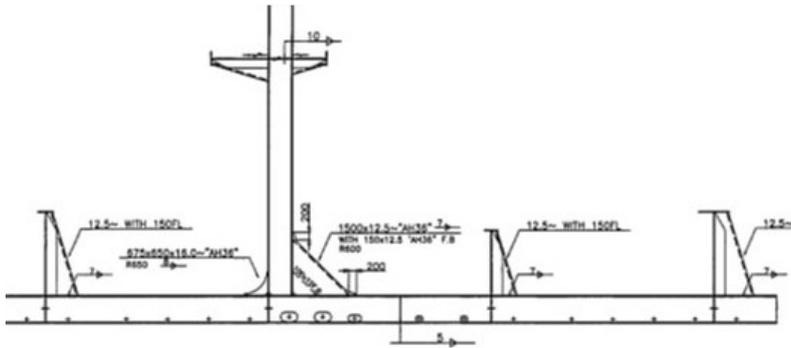
120. Cracks were found in bottom longitudinals in way of a transverse bulkhead on other ships that either had brackets forward of the bulkhead only or had brackets on both sides of the bulkhead. STELLAR DAISY had 1,500 x 1,500 x 12.5 mm brackets fitted with a 150 x 12.5 mm buckling plate on the forward side of the transverse bulkheads and smaller 675 x 650 x 16 mm soft toe brackets on the aft side of the bulkheads (*see Figure 18*). KR determined that 21 of the cracks reported in bottom longitudinals were not fitted with a bracket. The other 17 extended from the toe of the bracket. In addition, on some of the converted VLOCs two or more adjacent bottom longitudinals were found cracked in the same tank.

Figure 18: Bottom longitudinal brackets in way of the transverse bulkhead in the wing tanks.

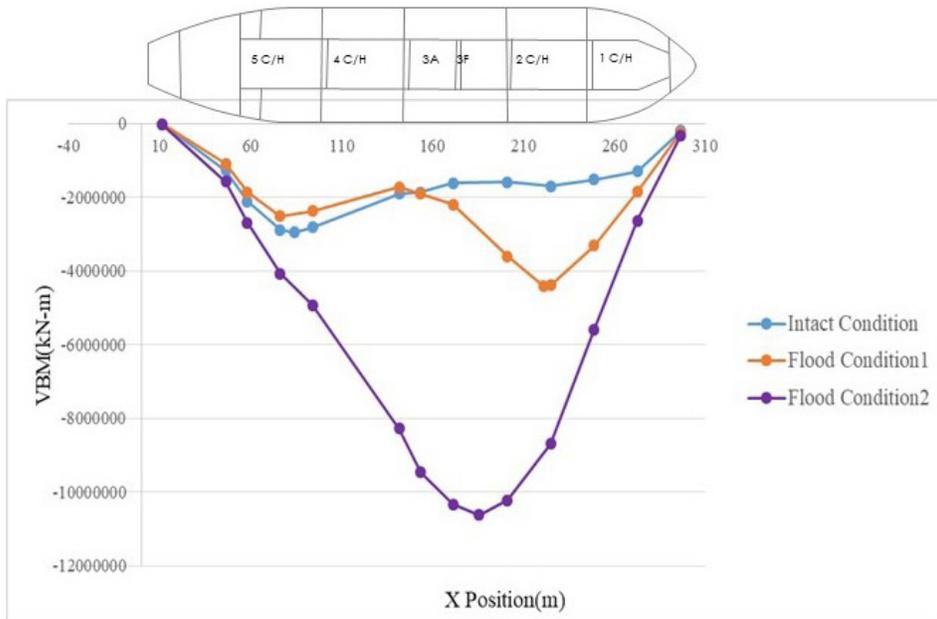
122. KR determined that with No. 2 P WBT flooded, the bending moment would have been 81% and the shear force would have been 66% of the maximum at-sea values. With Nos. 2 and 3 P WBTs flooded, the calculated bending moment was 192% and the shear force was 80% of the allowed at-sea values. Using the calculated bending moments based on the ship's loaded condition as a reference, the maximum still water bending moment increased by approximately 100% when No. 2 P WBT was flooded and by 400% when Nos. 2 and 3 P WBTs were flooded. The location of the maximum bending moment was at frame No. 55 when the ship was in an intact condition, between frame Nos. 78 and 79 when No. 2 P WBT was flooded and between frame Nos. 78 and 79 when Nos. 2 and 3 P WBTs were flooded (see Figure 19).

Figure 19: Still water bending moments.

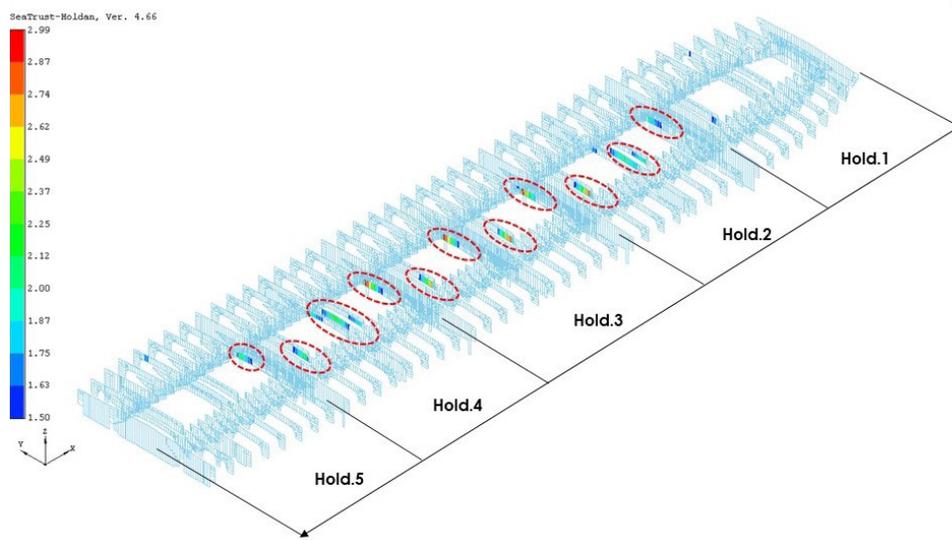
123. KR evaluated the potential for the ship’s transverse structure to buckle when No. 2 P WBT was flooded to the point where the ship would have been in equilibrium per ICLL 1966 as amended by the Protocol of 1988, regulation 27(13). Taking into consideration the ship’s loaded condition and the weather conditions that existed from 29–31 March 2017, it was determined that portions of the transverse structure between the hatch openings for Cargo Holds Nos. 2-5 would likely buckle (*see Figure 20*). KR also determined that buckling of the transverse structure would likely have begun before the tank was flooded to the point where the ship would have been in equilibrium.

Figure 20: Areas of potential buckling of the transverse structure with No. 2 P WBT flooded.

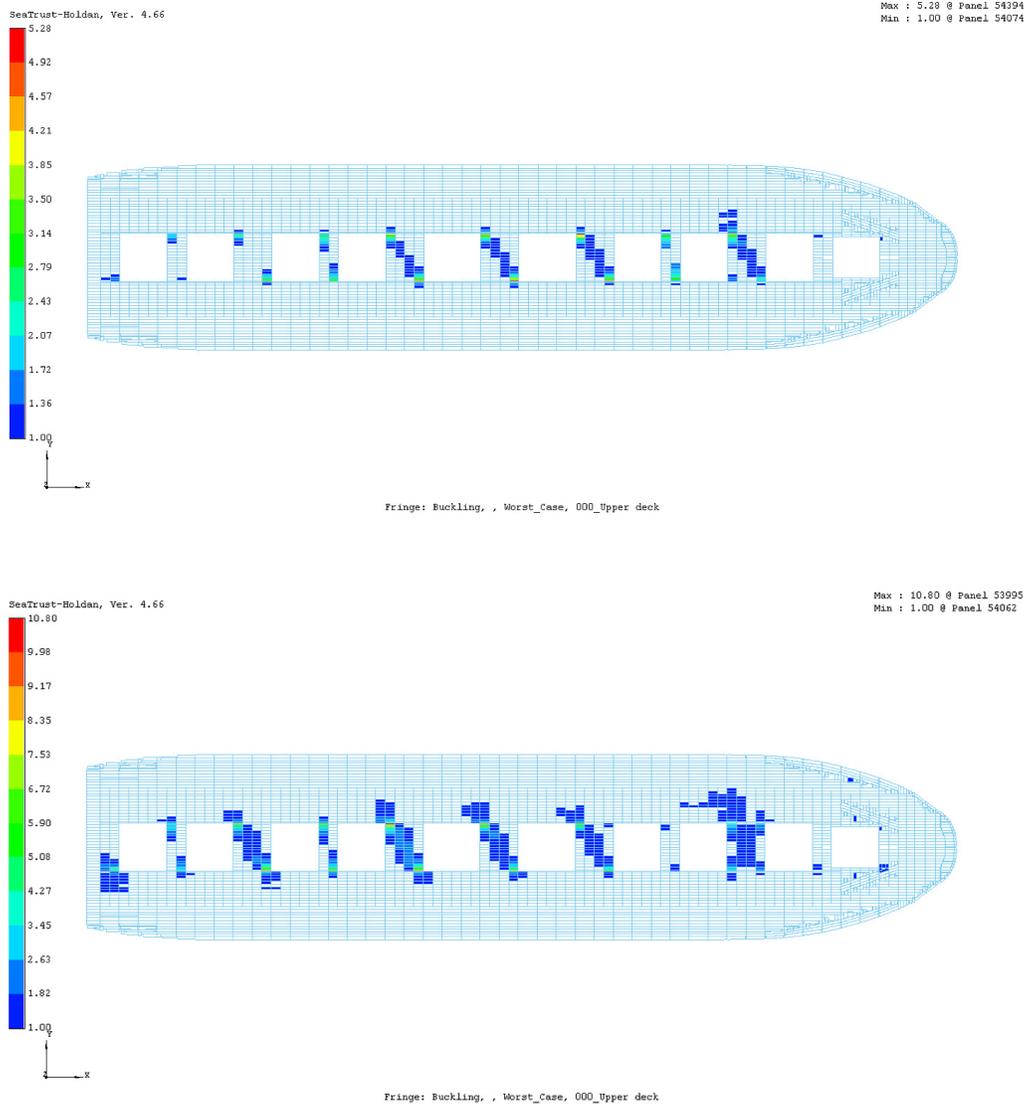
- 125. The buckling analysis was also conducted with both the No. 2 P and No. 3 P WBT flooded. The analysis indicated that buckling of the transverse structure between hatch openings would be more severe than with only the No. 2 P WBT flooded. It was also determined that multiple transverse bulkheads between cargo holds would likely collapse. The analysis also indicated that deck plate outside of the line of hatch openings would also be damaged. In addition, the deflection of the hatch coamings and covers would become more severe (see Figure 21).

Figure 21: Areas of the deck where the buckling criteria was exceeded with No. 2 P WBT flooded (upper) and with Nos. 2 and 3 P WBTs flooded (lower).

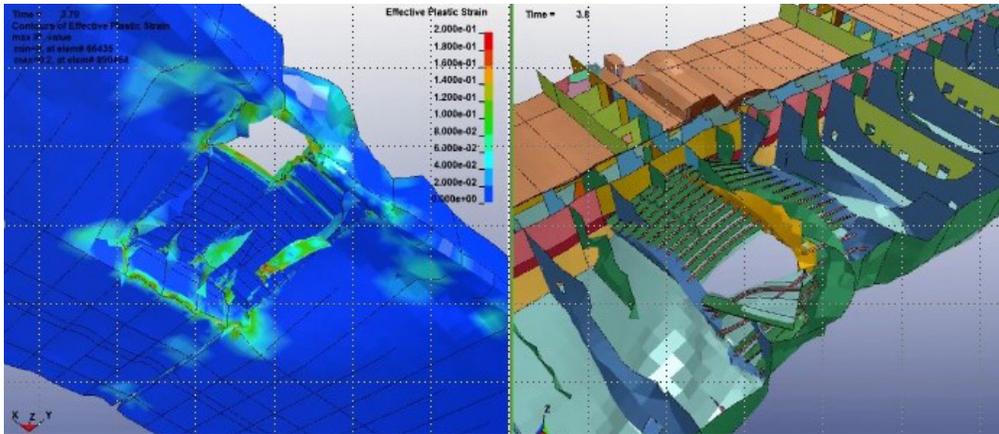
Taking into consideration STELLAR DAISY’s repair history and the number of cracks in bottom longitudinals that were identified on other converted VLOCs, managed by Polaris Shipping and classed by KR, after the loss of STELLAR DAISY, the flooding of No. 2 P WBT likely was the result of one or more cracks in bottom longitudinals that either were not detected when the tank was last inspected in October 2016 or that developed after the inspection. As the crack, or cracks, grew, the pressure on the bottom shell as the ship rolled under the influence of the high GM_0 would have imposed additional stresses on the hull structure that could cause latent cracks in other bottom longitudinals to grow or for a fatigued bottom longitudinal to fail. As a result, the size of the crack would likely increase and potentially lead to a loss of shell plate and cause massive, uncontrollable flooding (see Figure 22).

Figure 22: Graphic showing potential damage to the bottom plate and internal structure based on a transverse brittle fracture originating forward of the transverse bulkhead at frame No. 75. The hole in the bottom of No. 2 P WBT is approximately 15 m².
