Grounding of *ABFC Roebuck Bay*

Henry Reef, Queensland | 30 September 2017

ATSB Transport Safety Report
Marine Occurrence Investigation
MO-2017-009
Final – 27 June 2019

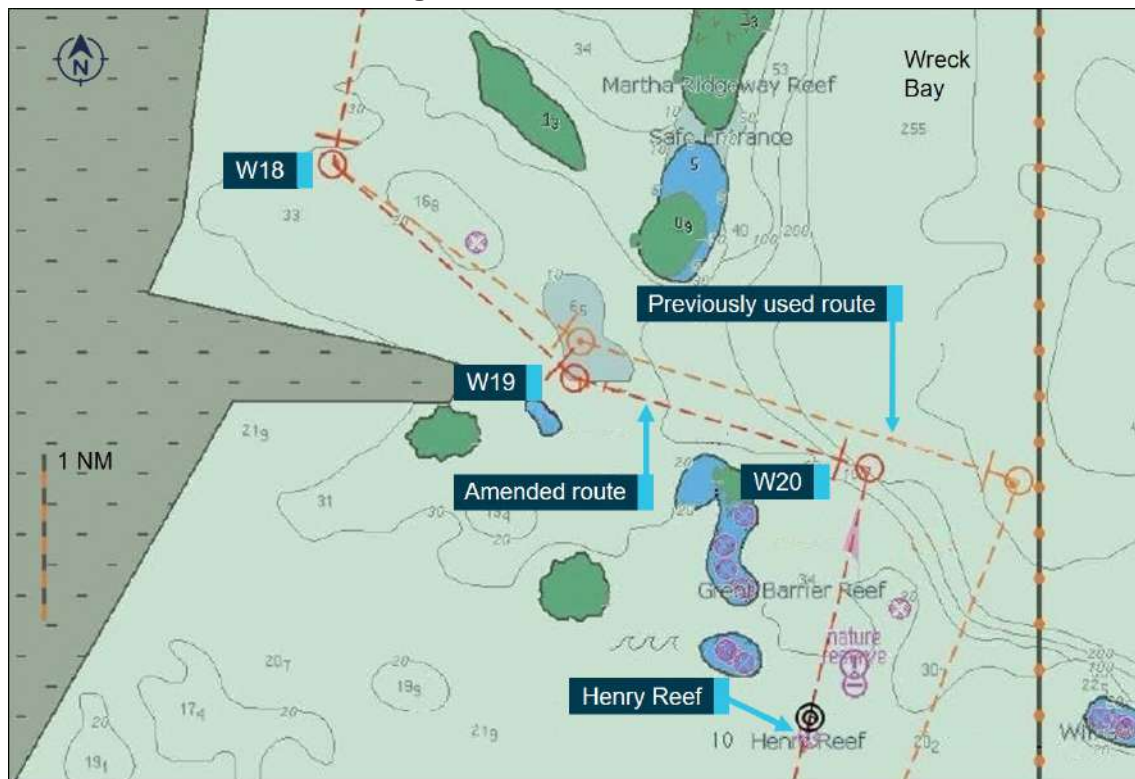
Figure 2: Image from *ABFC Roebuck Bay*'s ECDIS showing the section of the overall route with the amended route legs

When the master tried to save the amended route, the 'Errors' tab in the route tab folder of the ECDIS's 'Edit Route' menu turned yellow indicating an error in the route. The master advised the navigation officer of his desired amendments to the route and of the error encountered. The navigation officer reviewed the route's waypoint list in the ECDIS's route editor table and found the error to be an incorrect turn radius for one of the waypoints. The turn radius was amended, which cleared the error; the error tab reverted to its normal grey colour and changed to 'No Error'. The master and navigation officer then reviewed the amended route visually and saved it.

Image from *ABFC Roebuck Bay*'s ECDIS display, taken after the grounding, showing the previously used route (orange) and the amended route (red) based on the changed waypoints, W19 and W20.

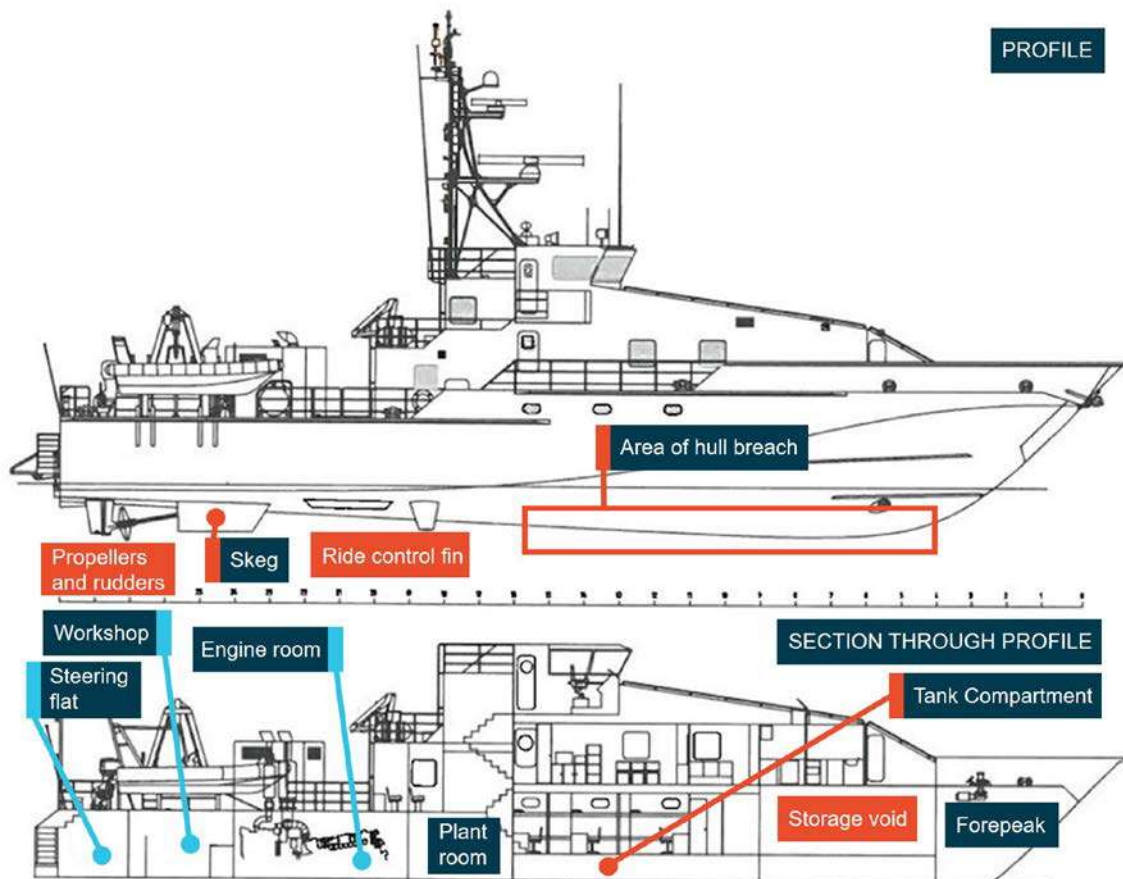
Figure 6: Section of general arrangement plan showing affected spaces

The master, who was in his cabin and was woken by the impact of the grounding, went to the bridge and activated the general emergency alarm. The cutter's crewmembers mustered and were all accounted for. They established that the cutter was aground on a reef and immediately began implementing damage control measures. Initial damage reports indicated that there was water ingress to the storage void space and the tank compartment immediately aft of it, while other spaces and compartments appeared to be intact (Figure 6).

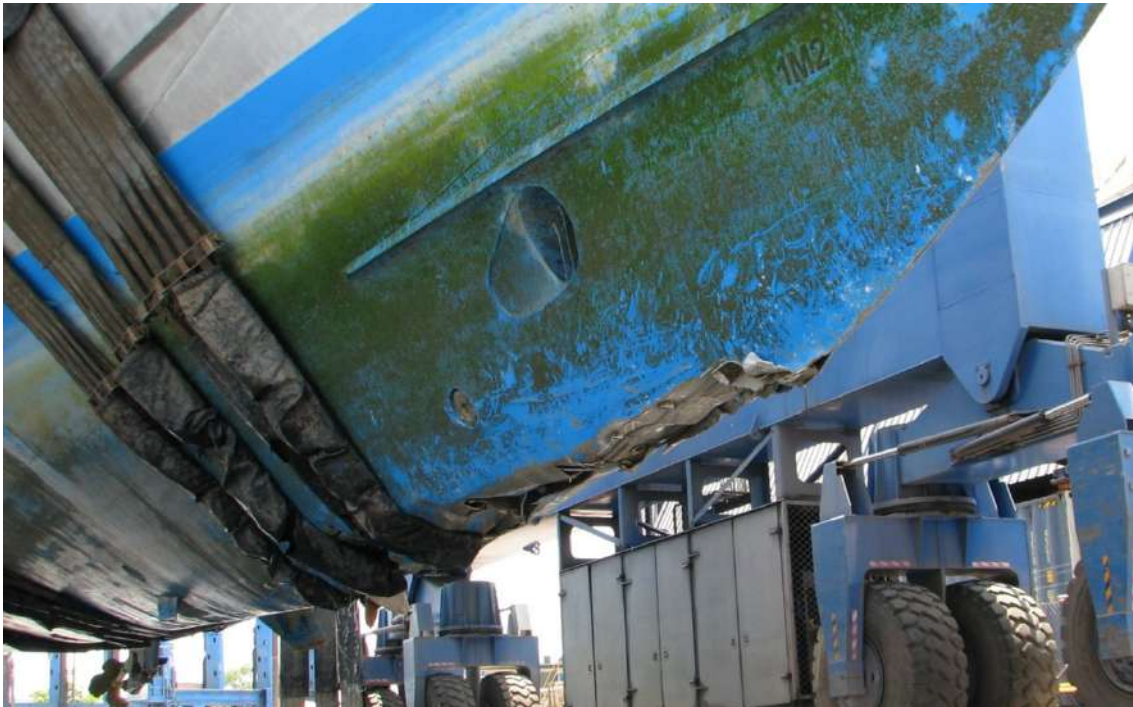
Figure 9: Damage to ABFC Roebuck Bay's keel

ABFC Roebuck Bay sustained substantial damage as a result of the grounding rendering the cutter unseaworthy. The storage void space and tank compartment (Figure 9) were both breached and flooded in way of the keel section with significant seawater damage to all electrical fittings in the two spaces.

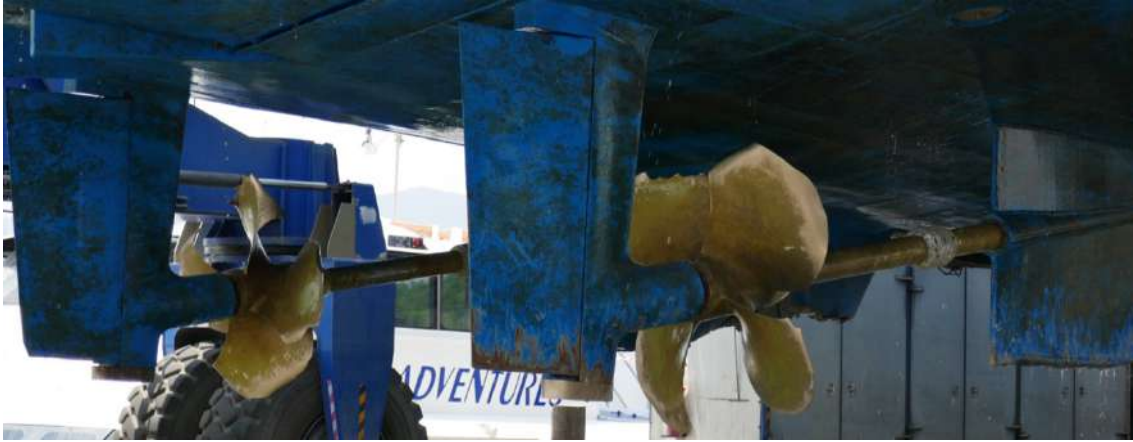
Figure 10: Damage to ABFC Roebuck Bay's propellers, rudders and skegs

Externally, the port and starboard ride control fins were found holed and bent. Similarly, the port and starboard skegs were found breached with a loss of watertight integrity and both stern tubes had sustained misalignments. The port and starboard propeller blades were also found to have

sustained extensive damage, especially to the blade tips, and both rudders showed minor deformation to the lower section of their trailing edges (Figure 10).¹⁶

¹⁶ The cutter has since been repaired and, after a period of sea trials, was returned to active service in September 2018.

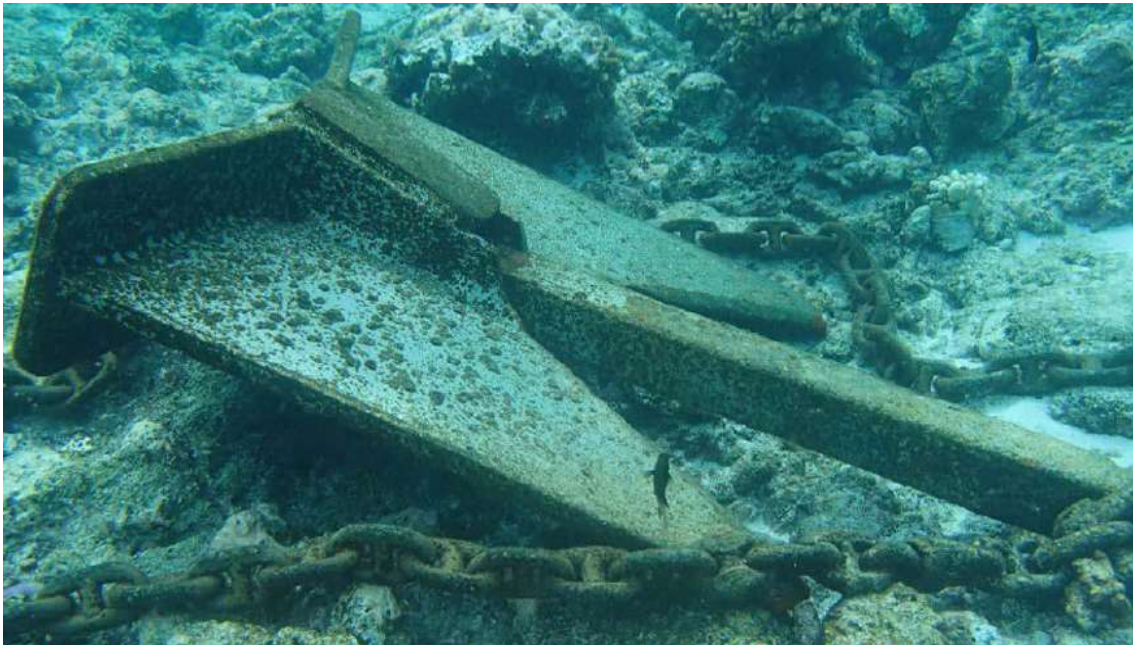
Figure 11: ABFC Roebuck Bay's anchor and chain on Henry Reef

In October 2017, officers from the Great Barrier Reef Marine Park Authority and Queensland Parks and Wildlife Service conducted a site assessment of Henry Reef. The assessment found that the maximum extent of physical reef damage occurred within an area of about 990 m² on the north-western aspect of Henry Reef.¹⁷ At the time of the assessment, ABFC Roebuck Bay's 184 kg anchor and about 150 m of anchor chain remained on the reef (Figure 11).

The assessment report concluded with recommendations to remove the anchor, chain and any other metal and anti-foul paint still on-site and to stabilise coral debris on the reef. In November

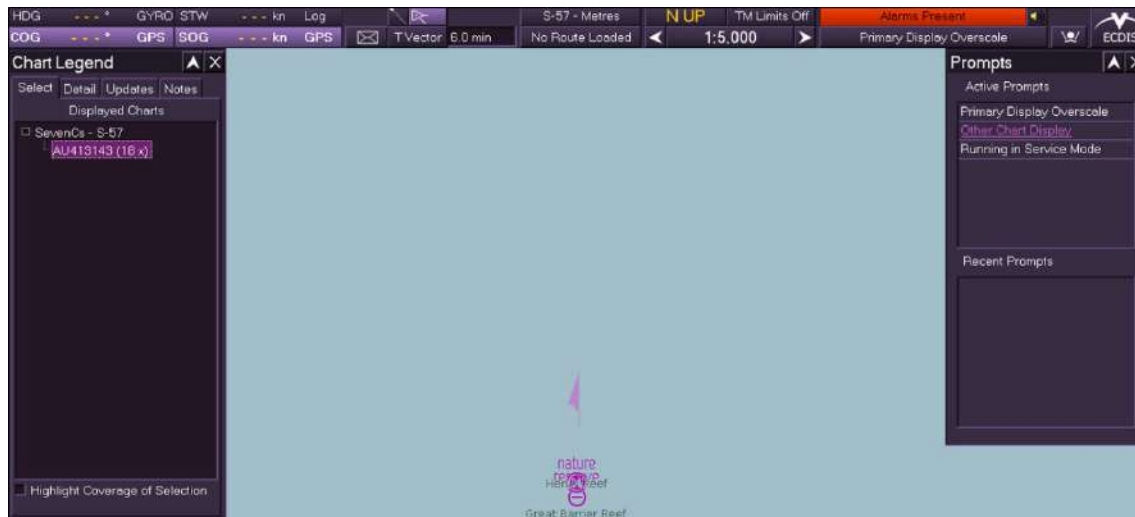
Figure 14: Image of ENC AU413143 showing no overscale pattern

Image of a VisionMaster FT ECDIS display showing ENC AU413143 at a scale of 1:5,000 and displaying no overscale pattern.
Source: Northrop Grumman Sperry Marine, modified by the ATSB

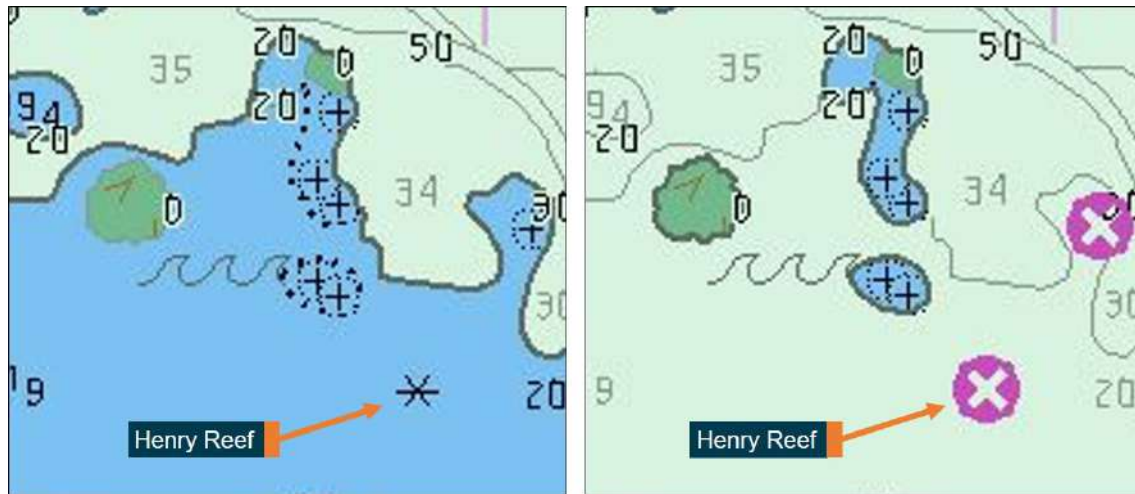
Figure 19: Henry Reef on ENC AU413143, displaying conditional symbology

Image on left shows Henry Reef displayed as a 'rock awash' symbol when lying within the user-defined safety contour. The image on the right shows Henry Reef displaying as an 'isolated danger symbol' when lying outside the user-defined safety contour.
Source: Australian Hydrographic Office, annotated by the ATSB

The IHO presentation library applicable at the time of the grounding, PresLib 4.0, mandated that the user be given the option of displaying the isolated danger symbol even for features in waters shallower than the safety contour value. However, some ECDIS operating on previous versions of the presentation library, including the ECDIS on board *ABFC Roebuck Bay*, always displayed the isolated danger symbol for applicable features regardless of their location in relation to the safety contour. Therefore, on *ABFC Roebuck Bay*'s ECDIS, Henry Reef always displayed as an isolated danger symbol.

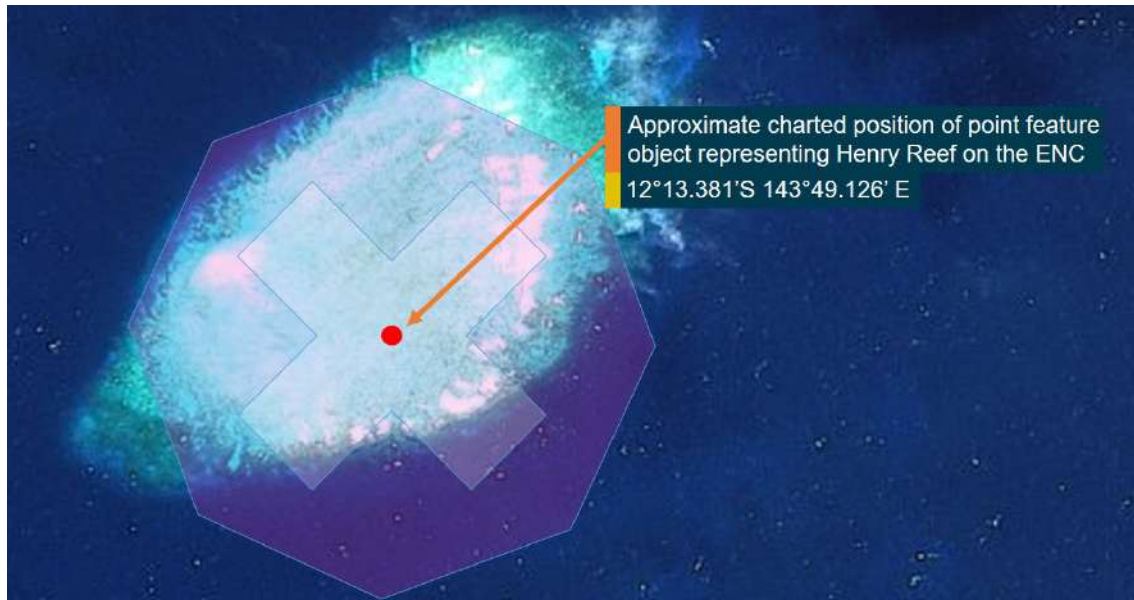
Figure 21: Charted position of Henry Reef point feature object on ENC

Image showing the charted 'point' position of Henry Reef as encoded in the ENC in relation to the actual reef. Note that the relative size of the isolated danger symbol to the reef is approximate only and that on the ECDIS display, the isolated danger symbol always displays at its standard size of about 7 mm regardless of scale.

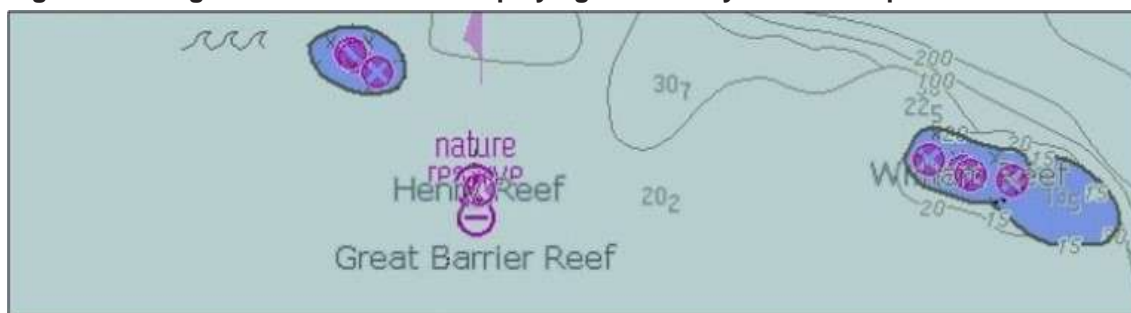
Figure 26: Image of ENC AU413143 displaying text and symbol overlap

Image shows ENC AU413143 centred on Henry Reef, at a scale of 1:40,000 on a VisionMaster FT ECDIS, demonstrating text and symbol overlap. Note that all text is on display as required by the Annex A - ECDIS start-up checklist.
Source: Electrotech and ATSB

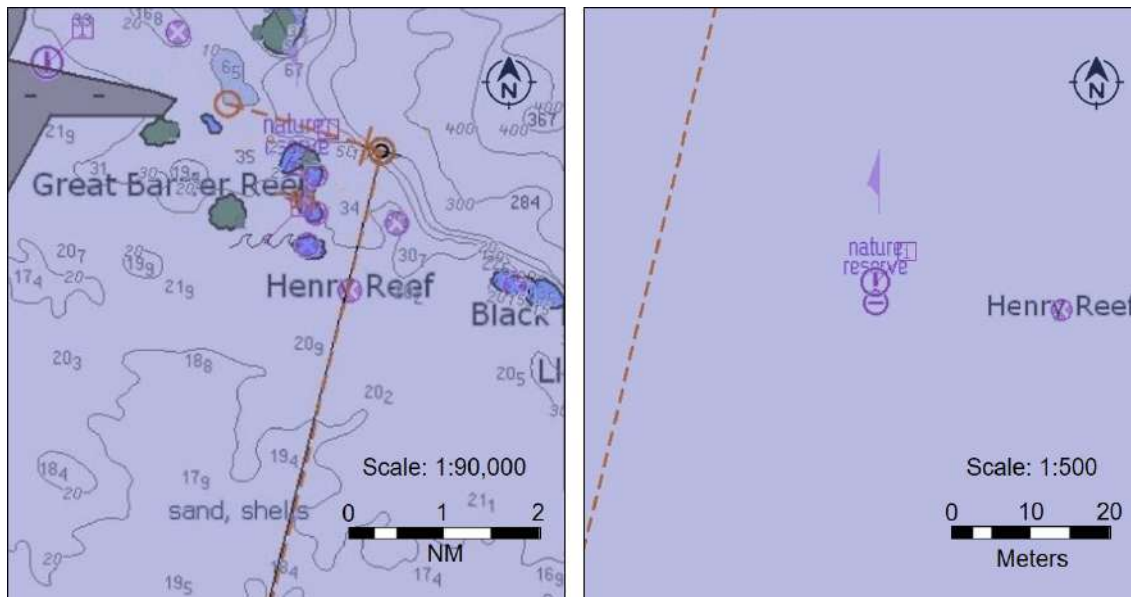
Figure 27: ABFC Roebuck Bay's planned route on the ECDIS showing the relative position of the isolated danger symbol representing Henry Reef at different scales

Image shows ABFC Roebuck Bay's amended route legs on the ECDIS at the compilation scale of 1:90,000 (left) and at the largest viewable scale, 1:500 (right).

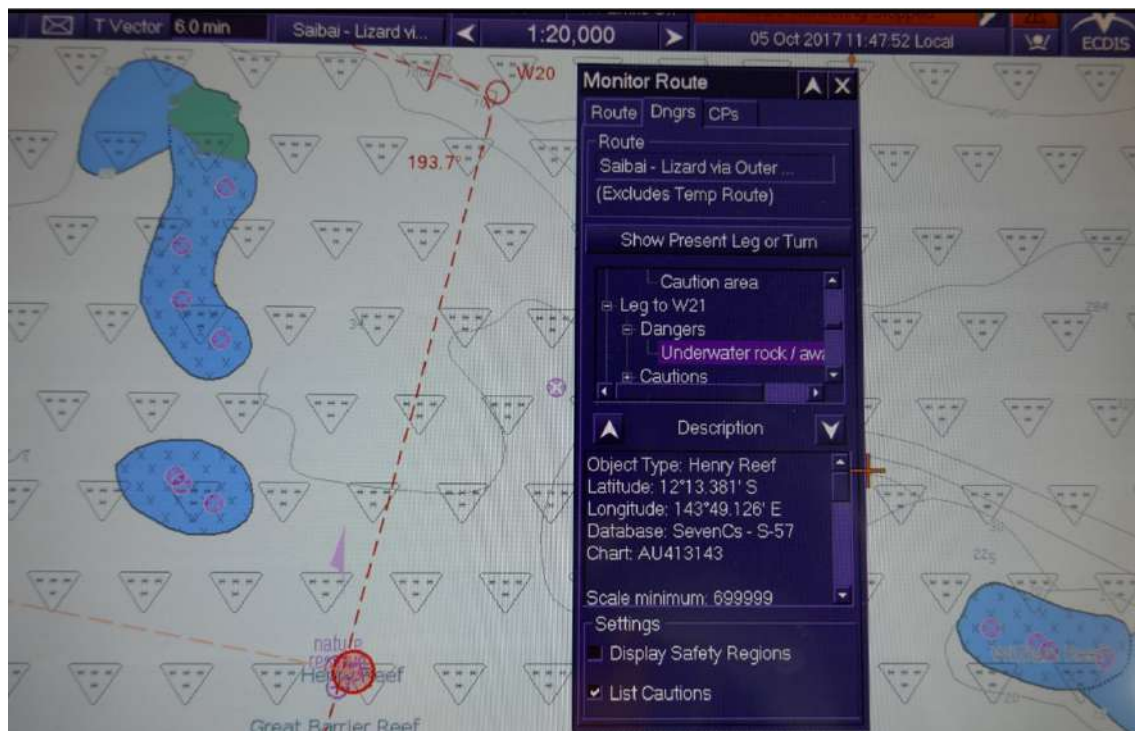
Figure 28: Image of ABFC Roebuck Bay's ECDIS showing the 'Monitor Route' window

Image of *ABFC Roebuck Bay's* ECDIS showing an identified danger (Henry Reef) on the leg to W21 in the dangers tab folder of the 'Monitor Route' window. Selecting the danger highlights the reef graphically on the ECDIS display and provides available information on Henry Reef. Source: ATSB

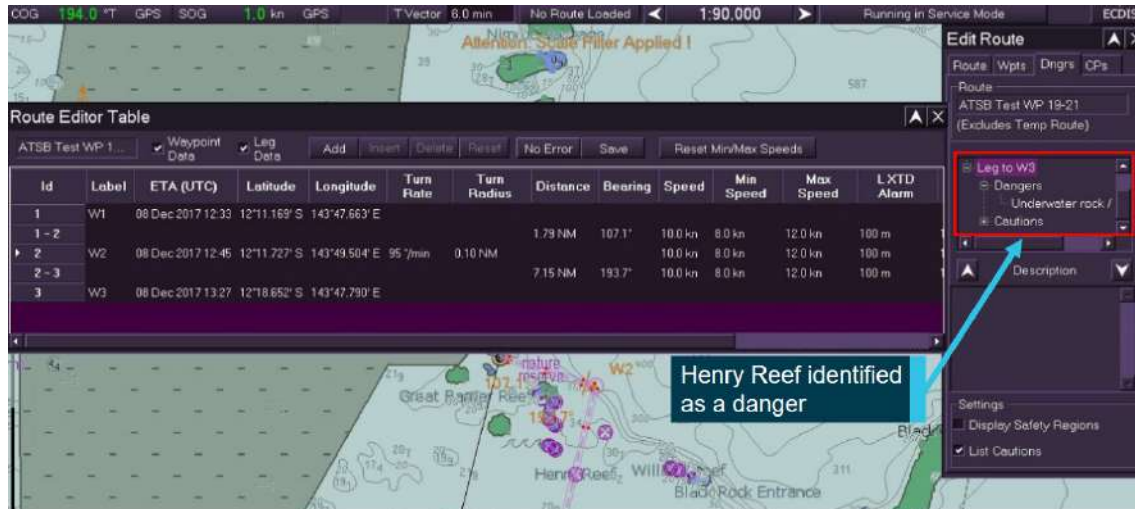
Figure 29: Danger identified on the amended route leg in the 'Edit Route' menu during testing

Image shows a danger (Henry Reef) identified by the ECDIS route dangers safety checking function on the amended route leg during ATSB testing. Note that the danger is not automatically highlighted on the chart and that the route validation function does not show any errors. Source: Electrotech and ATSB

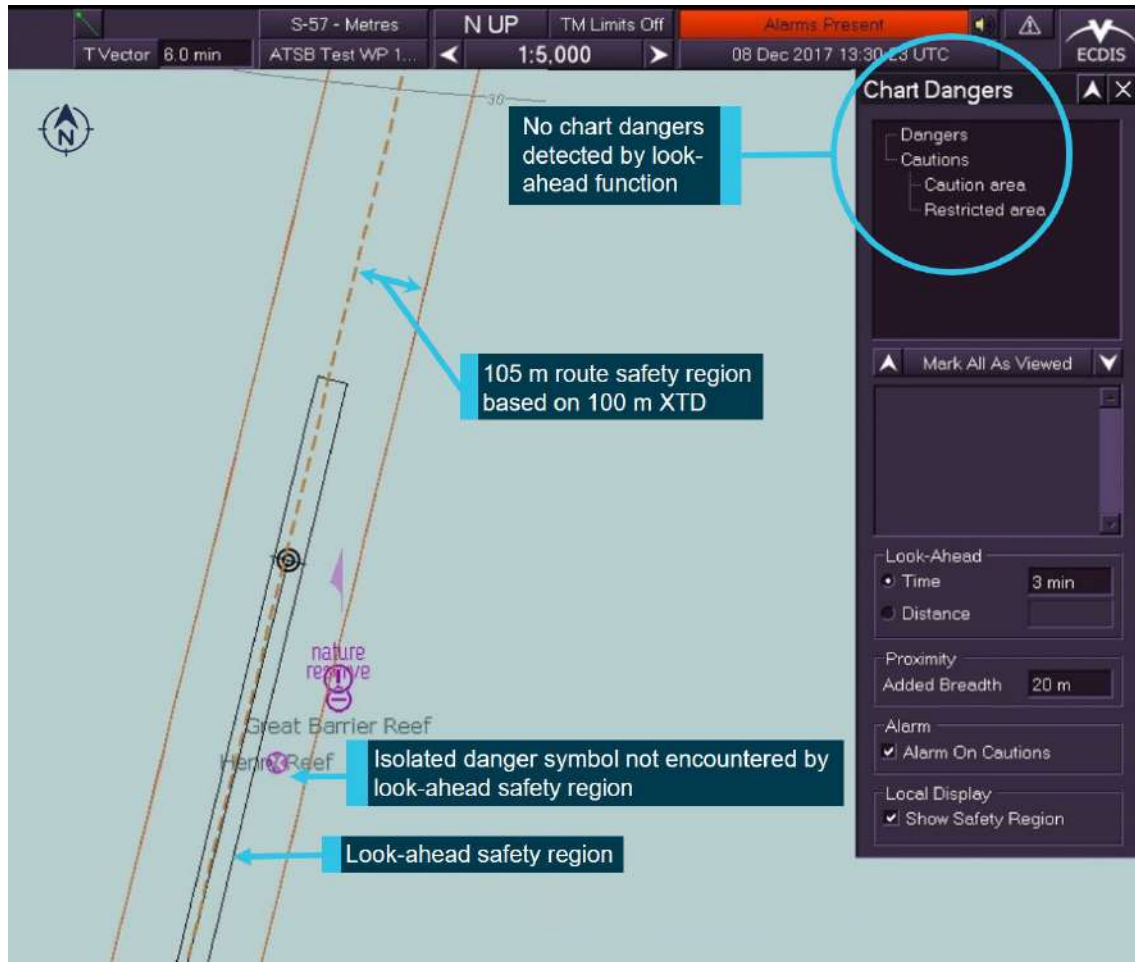
Figure 30: Image showing Henry Reef, undetected by the look-ahead function during testing

Image from ATSB testing showing Henry Reef going undetected by the ECDIS's look-ahead function when set up with a 20 m added breadth based on settings in the Annex A – ECDIS start-up checklist of the ABF work instructions.
Source: Electrotech and ATSB

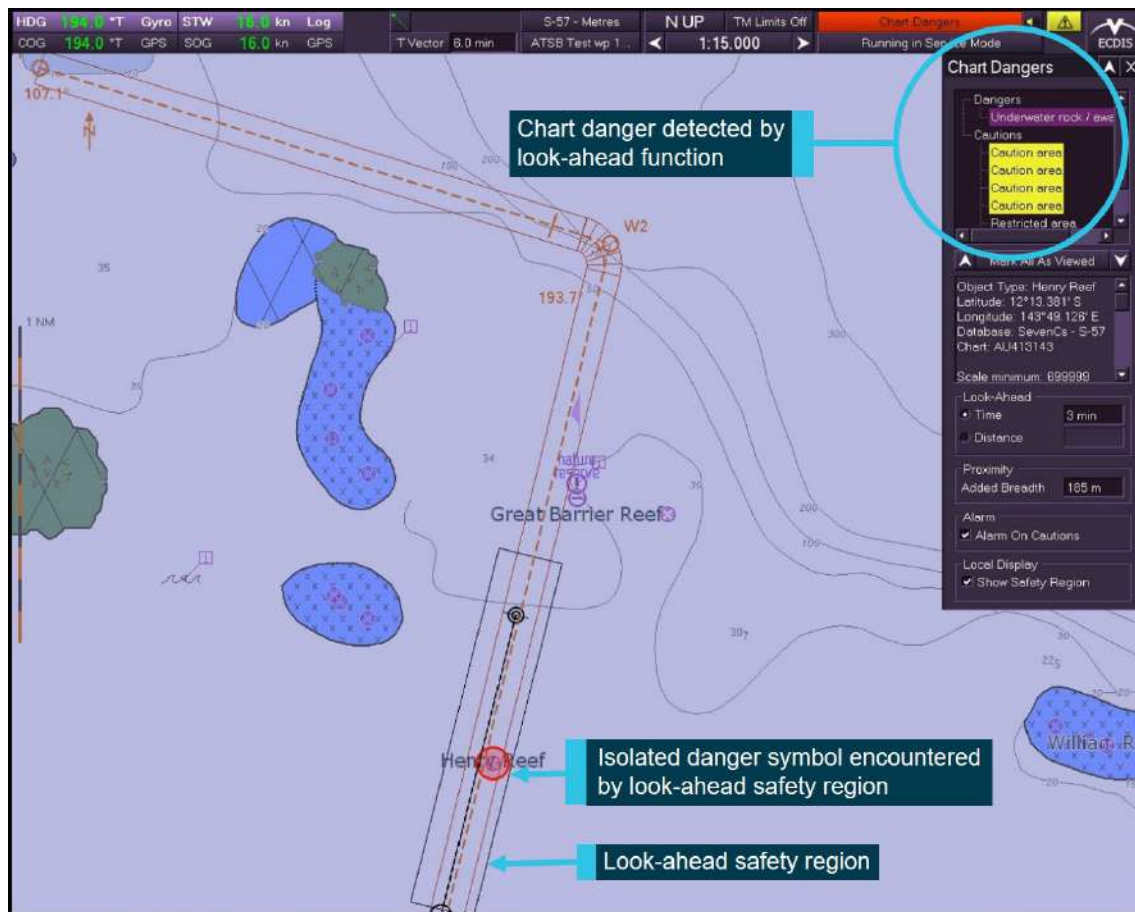
Figure 31: Image showing Henry Reef, detected by the look-ahead function during testing, based on the 'restricted waters' setting

Image from ATSB testing showing Henry Reef being detected by the ECDIS's look-ahead function when set up with a 0.1 NM (185 m) added breadth based on settings in the Annex C – Restricted waters category checklist of the ABF work instructions. Selecting the danger highlights the reef graphically on the ECDIS display and provides available information on Henry Reef.

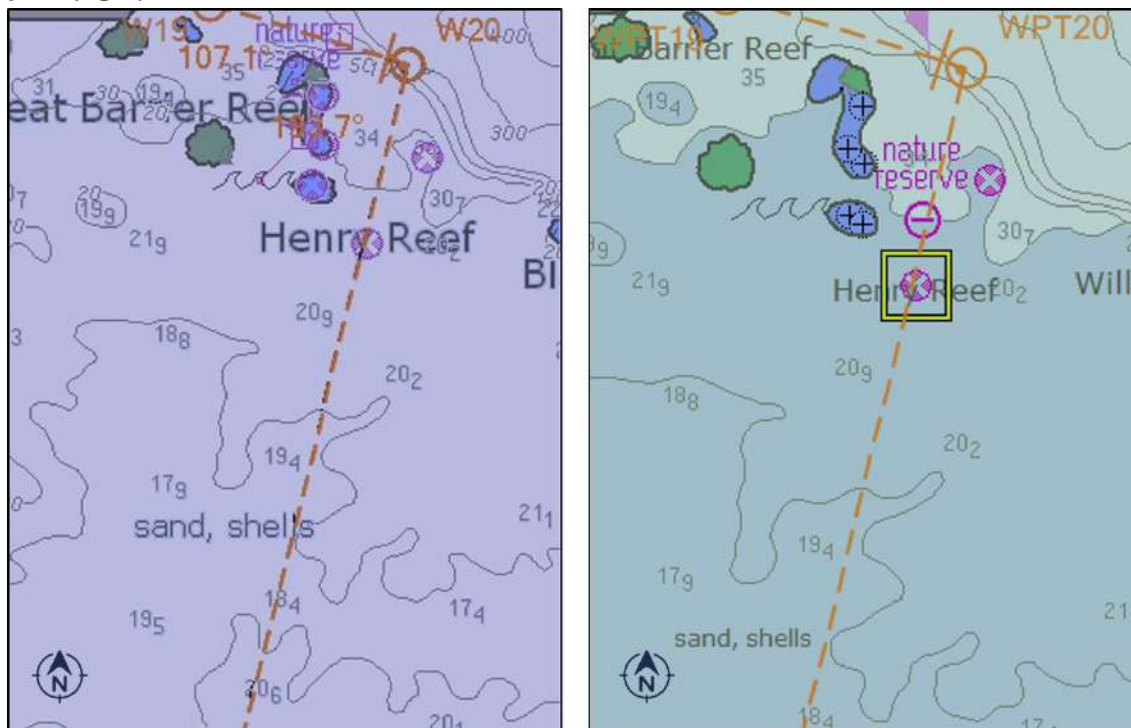
Figure 33: Images of ECDIS operating on PresLib 3.4 (left) and ECDIS updated to PresLib 4.0 showing indication highlight feature demonstrated on the amended route plan (right)

Image shows the amended route plan as it probably appeared on board ABFC Roebuck Bay (left) and as it might have appeared had the ECDIS been updated to PresLib 4.0 (right).

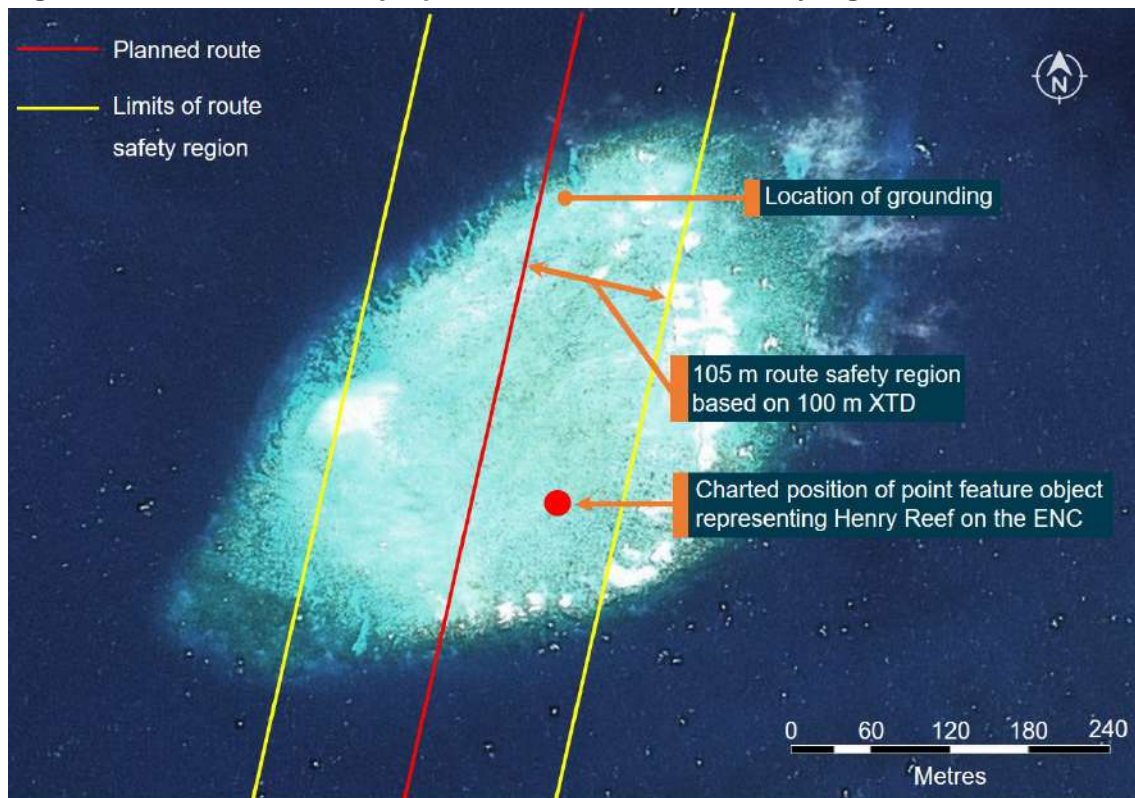
Figure 34: ABFC Roebuck Bay's planned route and route safety region

Figure showing ABFC Roebuck Bay's approximate planned route and the ECDIS route safety region based on a 100 m XTD in relation to the ENC's encoded position for Henry Reef. Note that the charted position of Henry Reef falls within the route safety region.
Source: DigitalGlobe, Esri, modified and annotated by the ATSB
