**MSC Samantha – 260518 – Accident
at Dubai Dry-Dock**

INCIDENT ANALYSIS REPORT – MSC SAMANTHA at DUBAI DRY DOCK

Type of Incident: **Electric Shock**

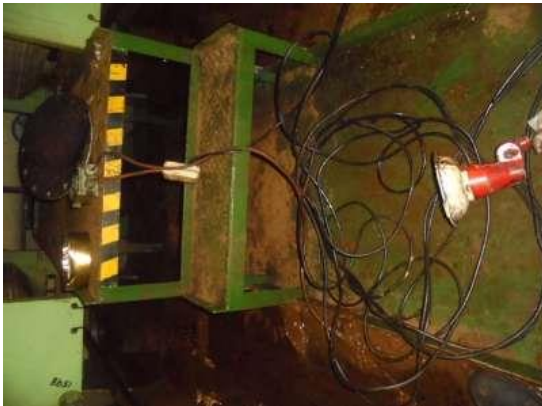
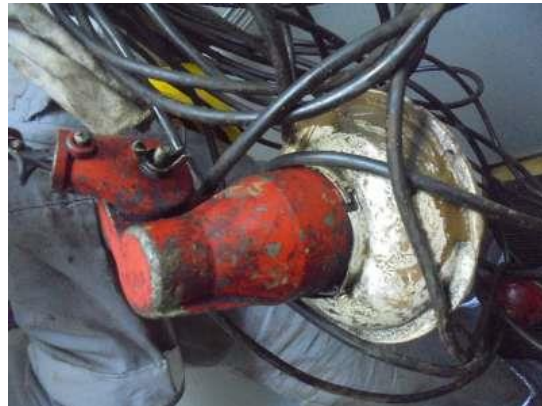
3/E had one foot inside the drip tray of the cooler where there was mud and water mixture from cooler cleaning. This must have made the electric circuit complete to earth.

When the light did not switch on, without switching off the power supply, the 3/E tried to adjust the bulb with casing of hand lamp on his body. During this time, he came in contact with broken wire (found later) with supply connected and not realizing that in case of any leak, the possibility of an electrocution was enormous.
