REPUBLIC OF THE MARSHALL ISLANDS

STELLAR DAISY CASUALTY INVESTIGATION REPORT

Loss of Buoyancy and Foundering with Multiple Loss of Life

South Atlantic Ocean | 31 March 2017

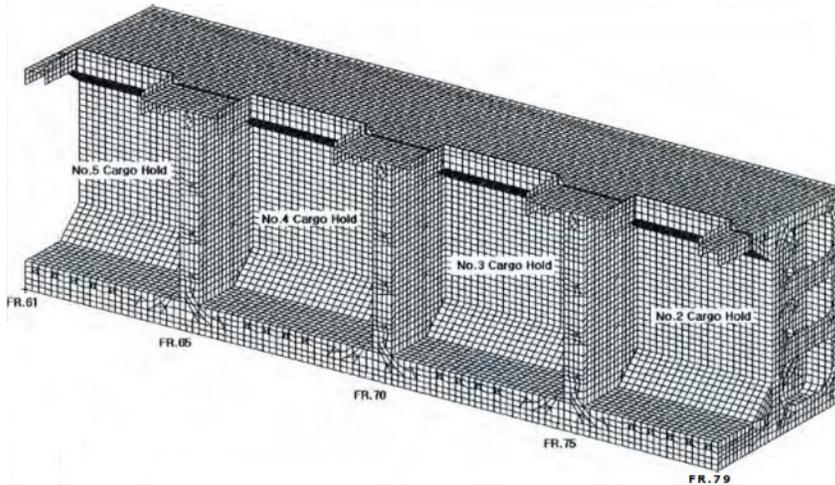
Figure 1: Midship half-breadth of STELLAR DAISY's hull that was modeled for the FEA. Note that Cargo Holds Nos. 3, 4, and 5 in the drawing refer to Cargo Holds Nos. 3F, 3A, and 4 on the General Arrangement Drawing.¹⁶

10. The FEA identified high shear stress in the web frame in way of where the new underdeck structure landed on the longitudinal bulkhead when the ship was loaded with a high density cargo. This was addressed by modifying the web frame to replace the existing grade AH plate with grade AH36 plate between longitudinal bulkhead longitudinals Nos. 5-7. The FEA also identified an area where the stress exceeded the allowed stress in the web frame in way of where the top of the hopper plate landed on the longitudinal bulkhead. The stress in this area was reduced by modifying the conversion design to include the installation of a girder at longitudinal bulkhead longitudinal No. 25 in each of the P/S voids and WBTs within the cargo length;¹⁷

12. The FEA concluded that although there were a number of areas where the stress was high, the conversion design was within the allowable limits for all loading conditions.²⁰

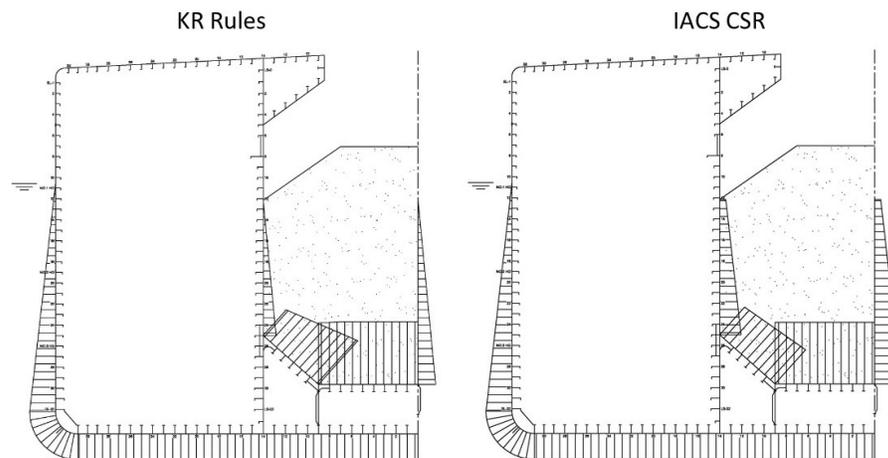
13. As part of the Administrator's marine safety investigation of the loss of STELLAR DAISY, Bruce S. Rosenblatt and Associates, LLC (BSR) was contracted to conduct an independent third-party FEA of the conversion design. The BSR FEA noted there was a difference between the cargo pressures on the boundaries of the cargo hold calculated using the KR Rules for Steel Ships and those calculated using the IACS Common Structural Rules, January 2006 edition as revised through Corrigenda 5 (CSR 2006, Corr.5) that were applicable when the design work for the conversion was being completed.²¹ These differences are most significant nearer the top of the cargo pile (see Figure 2). Therefore, load cases were developed and analyzed using both sets of rules. No areas of concern were identified with either load case. BSR did question whether these calculated pressures were adequate given that the pressure on the longitudinal bulkheads and supporting structure would increase due to the increased static list resulting from the flooding of wing tanks.²²

Figure 2: Scaled graphic representations of the static cargo pressures on the cargo hold boundaries based on KR Rules for Steel Ships (left) and IACS CSR 2006, Corr.5 (right). The pressures on the transverse bulkheads are shown to the right of the cargo pile.

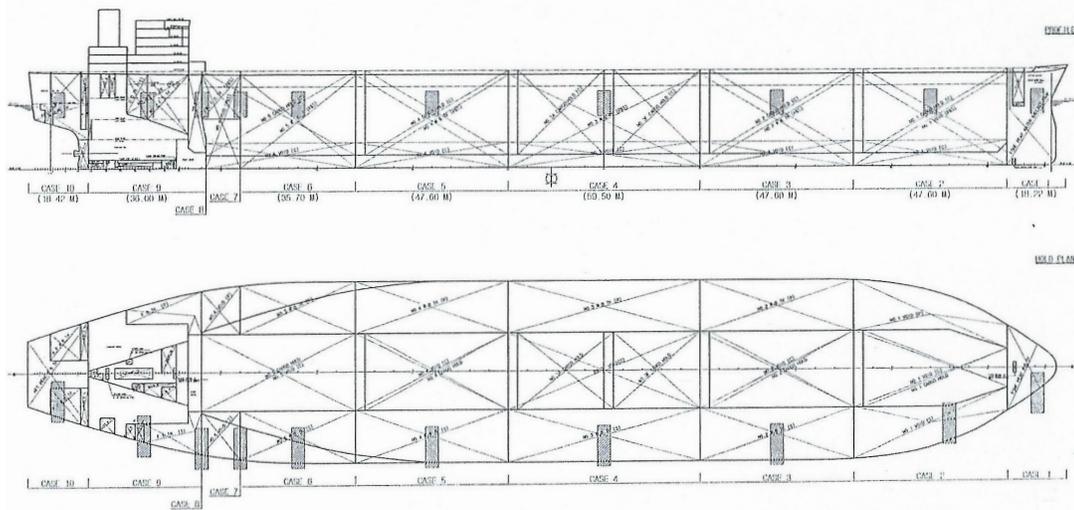
28. On 19 June 2009, KR approved the ship's intact stability and damage stability books.⁴² The approval was based on KR's determination that STELLAR DAISY complied with the requirements of the International Convention on Load Lines, 1966 as amended by the Protocol of 1988 (ICLL 1966 as amended by the Protocol of 1988), regulation 27(8) for a reduced freeboard assignment.⁴³ Ten damage conditions were considered as part of this determination. Of the seven damage conditions based on flooding of wing tanks in the cargo length, one involved flooding of Cargo Hold No. 1, which was sufficient to comply with the damage stability requirements of SOLAS regulation XII/4 (see Figure 7).⁴⁴

Figure 7: Damage conditions assessed to support the assignment of a reduced freeboard. The extent of the damage is shown by the grey rectangles. For the purpose of the assessment, it is assumed that the entire impacted space, or spaces, is flooded. (Source: Damage Stability Information.)

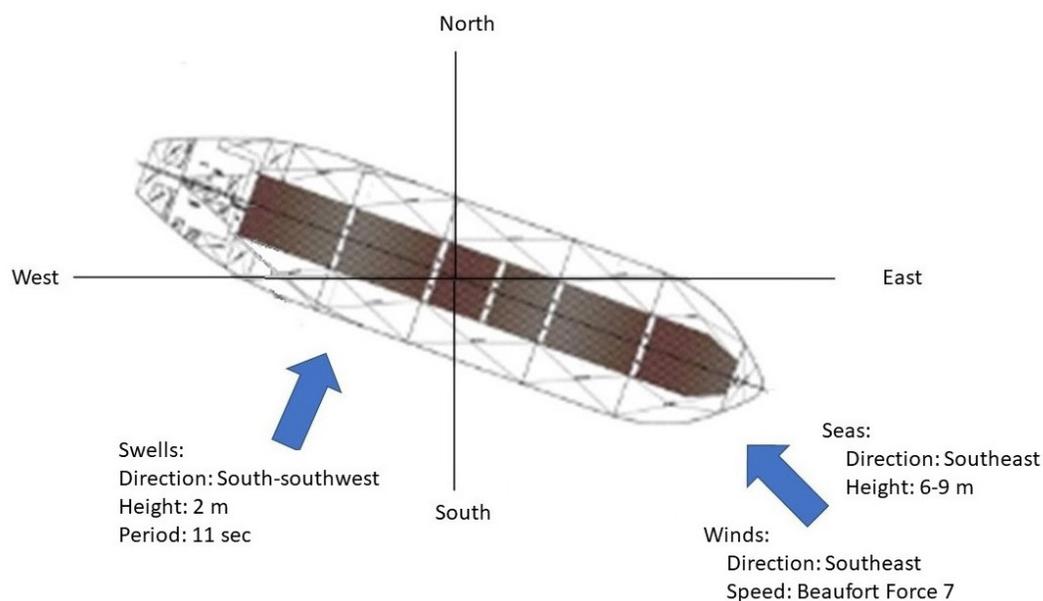
Figure 9: Wind and seas 29-31 March 2017.

After disembarking the Pilot on 26 March 2017, STELLAR DAISY maintained a southeasterly course toward the Cape of Good Hope. The weather worsened approximately two days after the ship's departure. Based on the ship's Noon Reports, Beaufort Force 7 winds and 6-9 m waves from the southeast were encountered for at least 72 hours before flooding was reported in the No. 2 P WBT. Based on the StormGeo forecast, there were also approximately 2 m swells from the southwest during this period (*see Figure 9*).

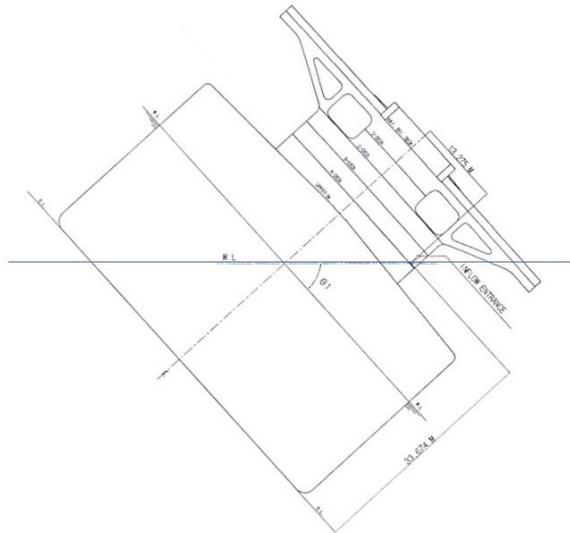
94. The AB stated that as the 3/O was making the distress call, he observed green water entering the Bridge through the door on the port side. He reported that the inclinometer indicated STELLAR DAISY had a 45° list to port (see Figure 10).¹³⁷ He also reported hearing a loud cracking sound on the port side but that he was not sure where it came from and that the ship rumbled like an earthquake. The AB reported he then ran out of the Bridge door and jumped into the water from the port side bridge wing. He did not provide an estimate of how long it was between when he first felt the ship start listing to port and when he entered the water.

Figure 10: Looking aft, waterline at a 45° list to port with a loaded draft of 20.2 m. The waterline shown does not take into consideration any draft increase due to flooding. (Source: Stability and Loading Manual.)

¹³⁷ Based on Polaris Shipping's calculations after STELLAR DAISY was reported lost, the down flooding angle was 43.338° , which is consistent with the value provided in the Stability and Loading Manual (p. 46).

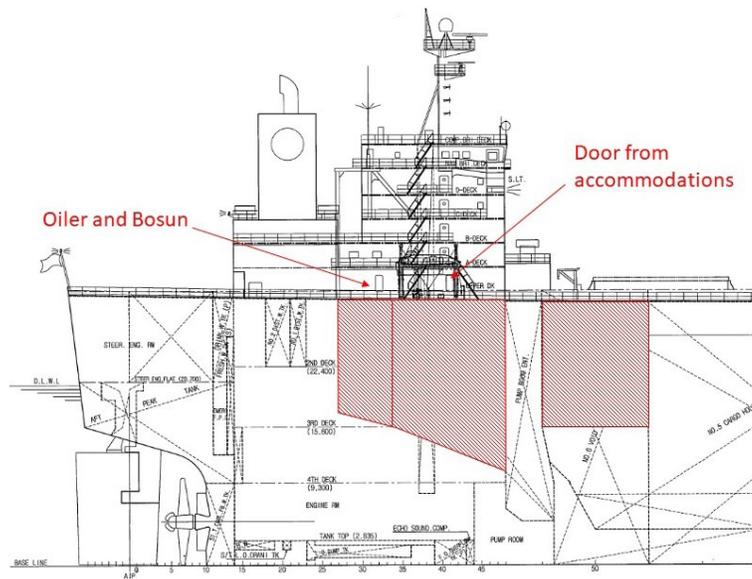
Figure 11: Location of Oiler and Bosun prior to the Oiler being washed overboard. The highlighted areas are fuel oil tanks (FOT). FOTs were in the same positions on the port side.

97. The Oiler described hearing what sounded like steel exploding. He then saw a wave of water and oil coming toward him from forward of the accommodations. The Oiler stated he was washed overboard when this wave hit him. The Oiler stated that he went underwater and was spun around before being pushed to the surface. He also stated the ship was gone when he surfaced and that he saw an immersion suit marked “BSN” floating nearby, which he grabbed. He then swam to a capsized life boat, which he stated was damaged on at least one side, and grabbed hold of it near the propeller. The Oiler put the immersion suit on while in the water in the vicinity of the life boat. After about 10 minutes, during which he reported calling out for other crewmembers and not receiving any response, the Oiler reported seeing two inflated life rafts, one of which was capsized, floating some distance away. He started swimming toward the life rafts while continuing to call for help.

The surviving Oiler reported he was washed overboard by a wave of water and bunker oil that came from forward of the accommodations. For this to occur, it was necessary for there to be a loss of structural integrity of one or more of the ship's FOTs and a loss of watertight integrity of the deck and side shell in way of frames Nos. 48-50 (see Figure 11).
