Grounding of *ABFC Roebuck Bay*

Henry Reef, Queensland | 30 September 2017

ATSB Transport Safety Report
Marine Occurrence Investigation
MO-2017-009
Final – 27 June 2019

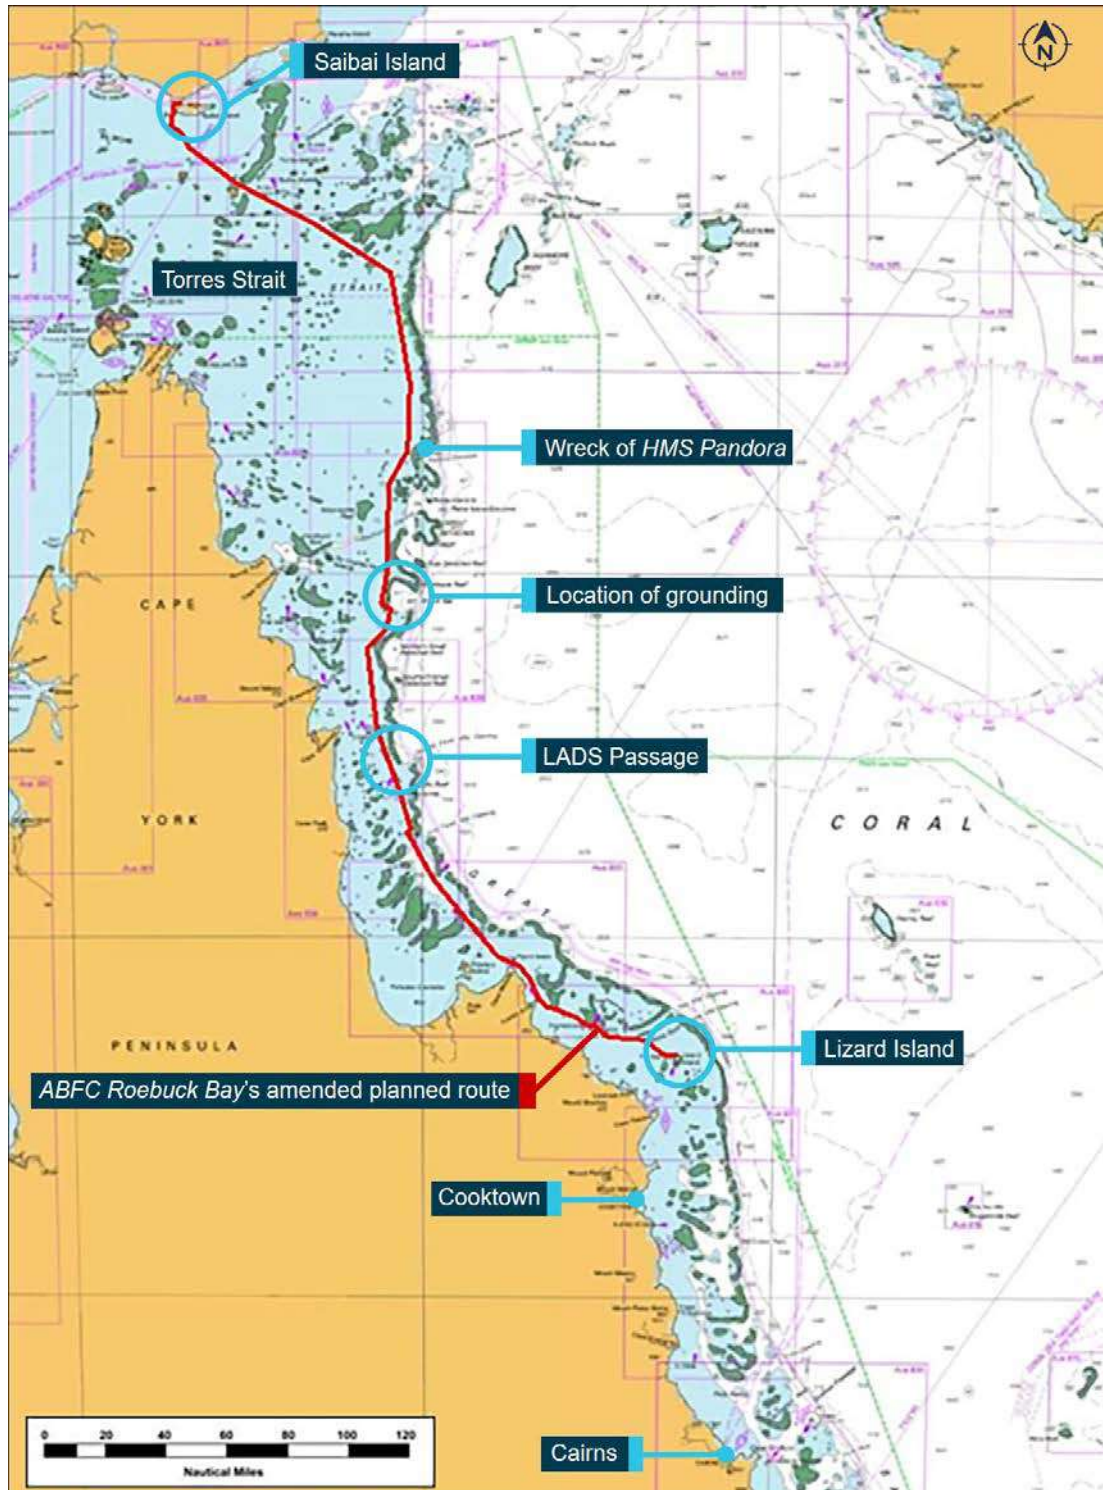
Figure 3: Section of navigational chart Aus 4620 showing ABFC Roebuck Bay's planned route and key locations

The passage plan was subsequently split into two routes with a brief stop at Lizard Island, Queensland before continuing on to Cairns for the end of the patrol. The two routes were then saved on the cutter's ECDIS and named 'Saibai to Lizard via Outer Reef' (Figure 3) and 'Lizard to Cairns'. No further changes were made to the route plan.

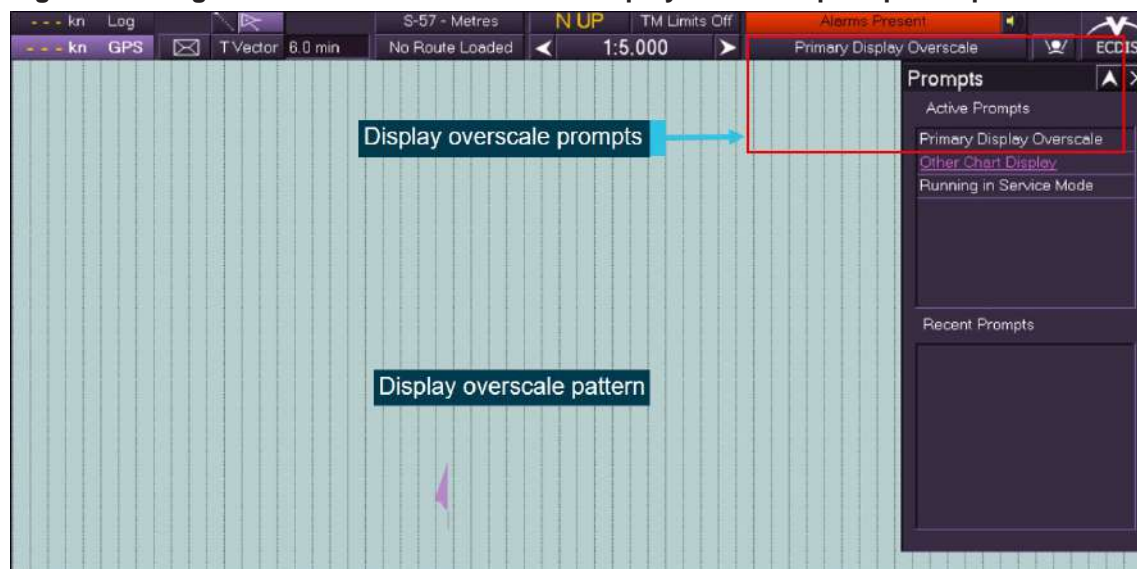
Figure 13: Image of a VisionMaster FT ECDIS display overscale prompt and pattern

Image shows the overscale display prompt and overscale pattern demonstrated on a different ENC of the same navigational purpose code and compilation scale as ENC AU413143.

During tests on chart AU413143, conducted by the ATSB and the manufacturer, it became apparent that, while the overscale text prompt appeared when the chart was viewed at scales larger than the compilation scale, the overscale pattern was not generated regardless of the scale at which the chart was viewed (Figure 14). However, the pattern did appear on other charts of the same compilation scale and navigational purpose as ENC AU413143 (see Figure 13).

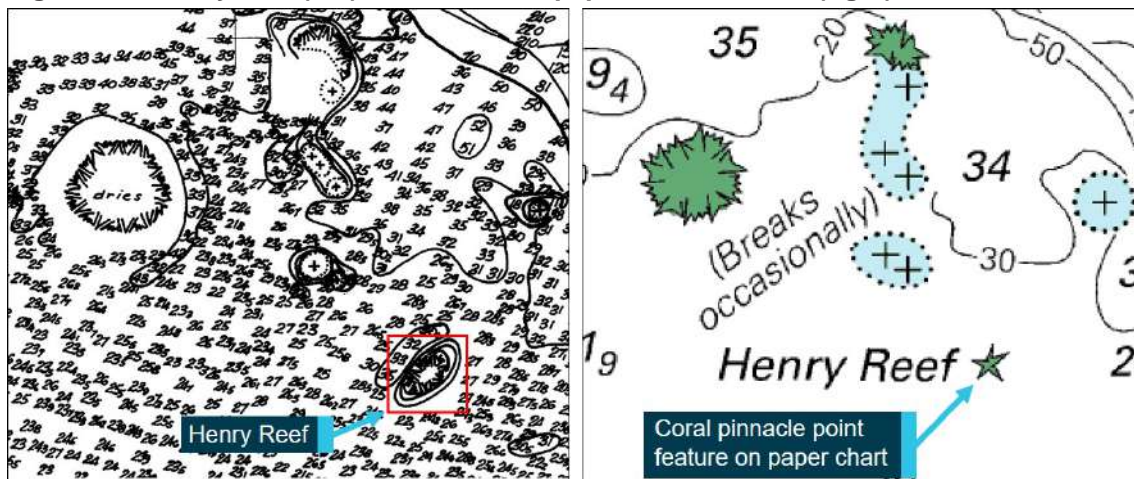
Figure 18: Survey data (left) and section of paper chart Aus 836 (right)

Image shows Henry Reef as surveyed (left) and Henry Reef represented by the 'coral pinnacle' symbol (right) on the paper navigational chart Aus 836.

Based on the paper chart's compilation scale and other factors, reefs of a certain size were represented as area feature objects while smaller sized reefs were represented by point feature objects. The AHO assessed that Henry Reef could be adequately represented by a point feature object. The symbol used to represent the reef was the 'coral pinnacle' symbol—a green, 5-pointed star-shaped symbol (Figure 18). The coral pinnacle symbol was used to represent coral reef point feature objects on Australian paper charts. This symbol was unique to Australian charts and has not been adopted into the IHO list of chart symbols and abbreviations.

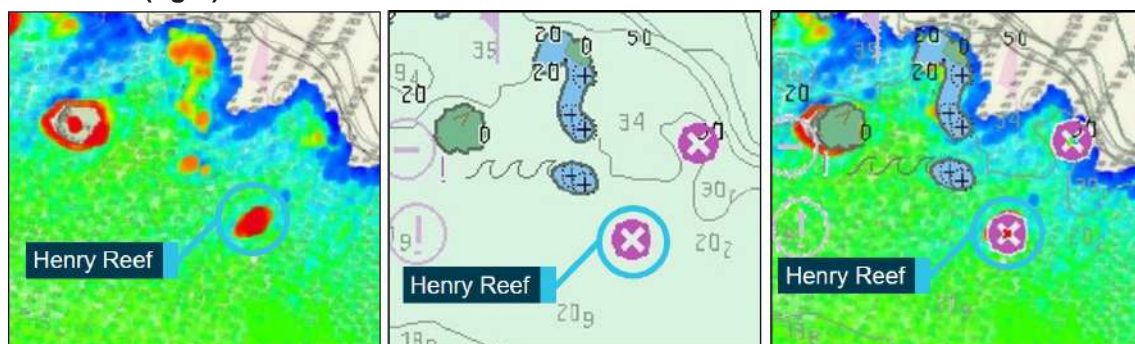
Figure 20: AHO survey data (left), AU413143 (centre) and survey data overlaid on AU413143 (right)

A cursory analysis of AHO survey data⁵³ obtained shortly after the grounding showed that, when superimposed on ENC AU413143 at compilation scale and, taking into account the position accuracy limits defined by the appropriate CATZOC, the isolated danger symbol appears adequately representative of the observed extent of Henry Reef (Figure 20). However, when viewed at scales progressively larger than the compilation scale, the symbol would progressively represent a smaller proportion of the reef on the ECDIS display.

Images show AHO survey data (left), section of ENC AU413143 (centre) and ENC AU413143 superimposed on survey data at compilation scale (right).

At compilation scale, the isolated danger symbol was reasonably comparable to the physical extent of Henry Reef (see Figure 20). A visual assessment of ABFC Roebuck Bay's planned route at compilation scale showed the route passing over Henry Reef (Figure 27, left). However, when viewed at progressively larger scales, the reef's isolated danger symbol appeared further away from the route. This could potentially give a false sense of sea room and safety.

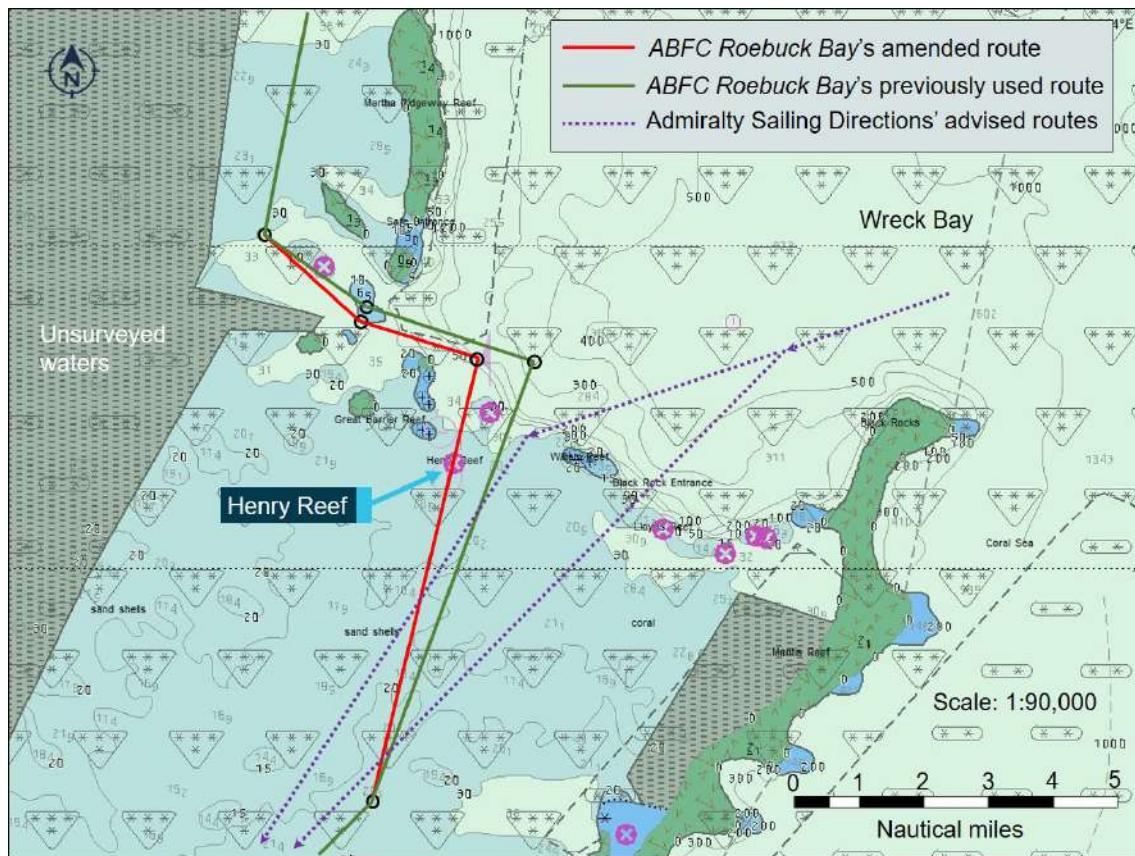
Figure 23: Section of ENC AU413143 showing CATZOCs and ABFC Roebuck Bay's routes compared to advice in the Admiralty Sailing Directions

The sailing directions provided information for safe navigation that was not available on charts or in other hydrographic publications. The sailing directions provided advice for small vessels on routes leading south through Wreck Bay (Figure 23). While the directions cautioned that these routes were not normally used, there were often operational reasons for ABF cutters to navigate in waters that would generally be beyond the scope of regular merchant vessels. The directions also advised that these routes could not be considered proven safe by regular use.

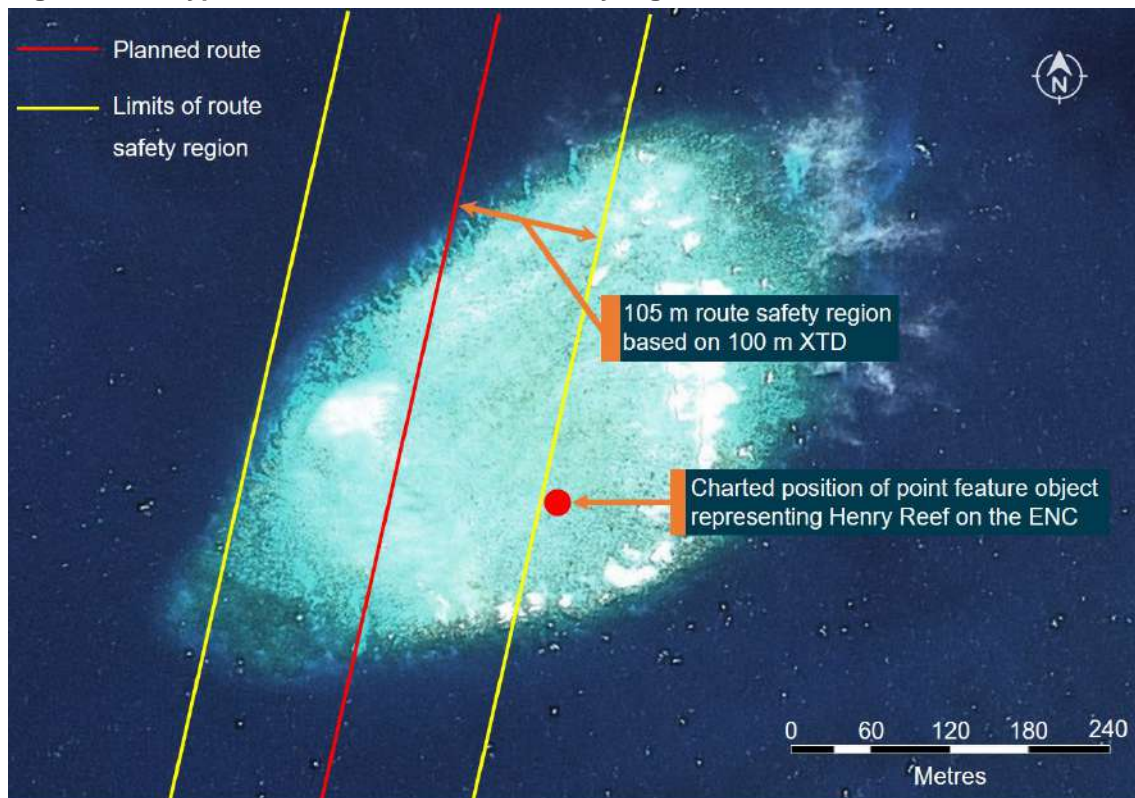
Figure 35: A hypothetical route and route safety region

However, when a point feature represents a physical feature of relatively significant size, it is possible for a part of the ECDIS route safety region to be obstructed by the feature despite its charted position falling outside the route safety region. If a hypothetical route were plotted about 55 m further to the west, the charted position of the point feature would now fall outside the ECDIS route safety region. In this case, the ECDIS would not have detected the reef as a danger to the planned route and it would not have been identified in the dangers tab folder. Nevertheless, the planned route and a significant proportion of the route safety region would remain across the reef (Figure 35). In this situation, *ABFC Roebuck Bay* would have potentially run aground with the ECDIS showing no identified dangers on the planned route. A similar scenario, and associated safety implications, would equally apply to the ECDIS look-ahead function and safety region.

Figure showing a hypothetical route laid about 55 m to the west of ABFC Roebuck Bay's planned route and the ECDIS route safety region based on a 100 m XTD. Note that the charted position of Henry Reef now falls just outside the route safety region. In this case, the route is still laid across Henry Reef but the ECDIS will not identify the reef as a danger on the route leg.

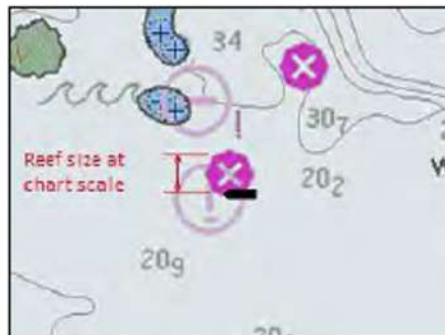
4. When the ENC is displayed correctly, the danger to a ship close to an isolated danger is clear.

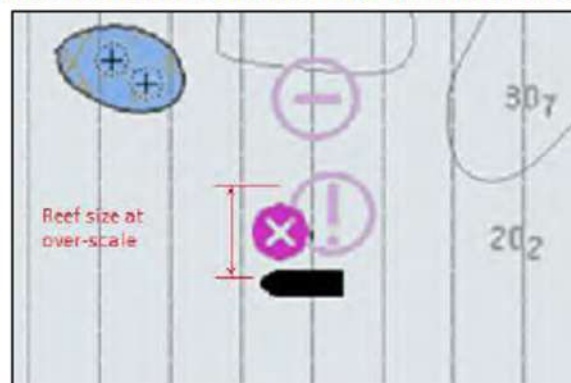
5. However, when displayed at over-scale, a ship the same unsafe distance from the isolated danger incorrectly appears to be safe because the isolated danger symbol is still the same size.

6. This is not more accurate, and is definitely not safe.
7. Remember, the positioning accuracy of the isolated danger may be worse than 500 metres. Routes should be planned to clear these dangers by at least as far as the ZOC category immediately around the danger dictates.
